Navajo Abandoned Uranium Mine

Site Screen Report

Mesa II, Mine No. 1 & 2, P-21 AUM Site

March 2010

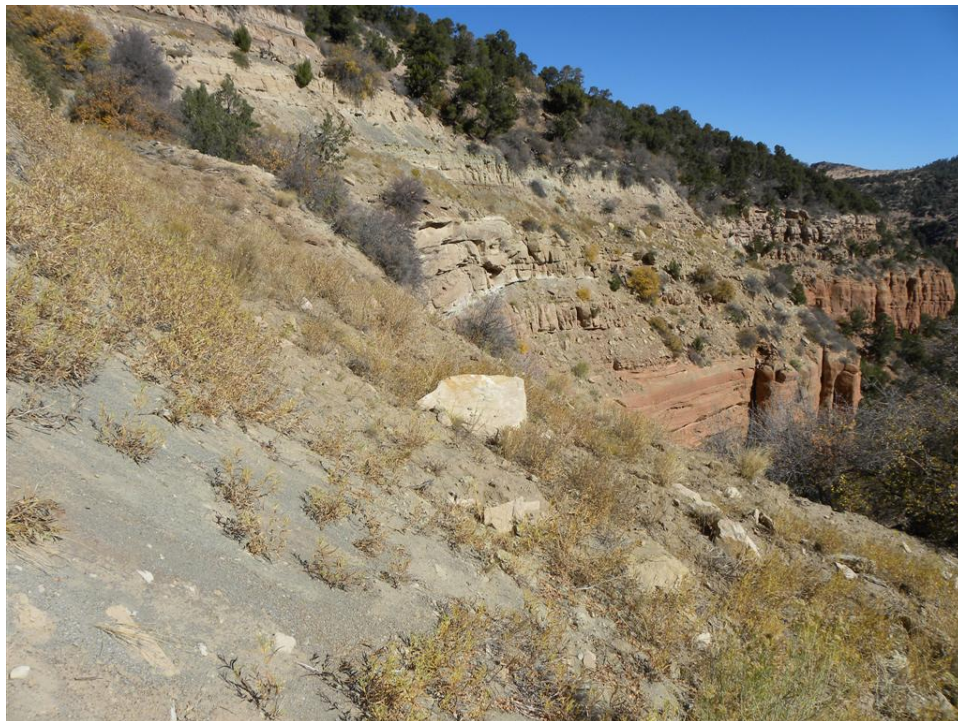
Possible waste piles along entire cliff side 300' x 100' ,with a total estimated volume of 5,556 yd³

Photo 1. Cliff area and waste rock

Unreclaimed waste pile; various mining debris

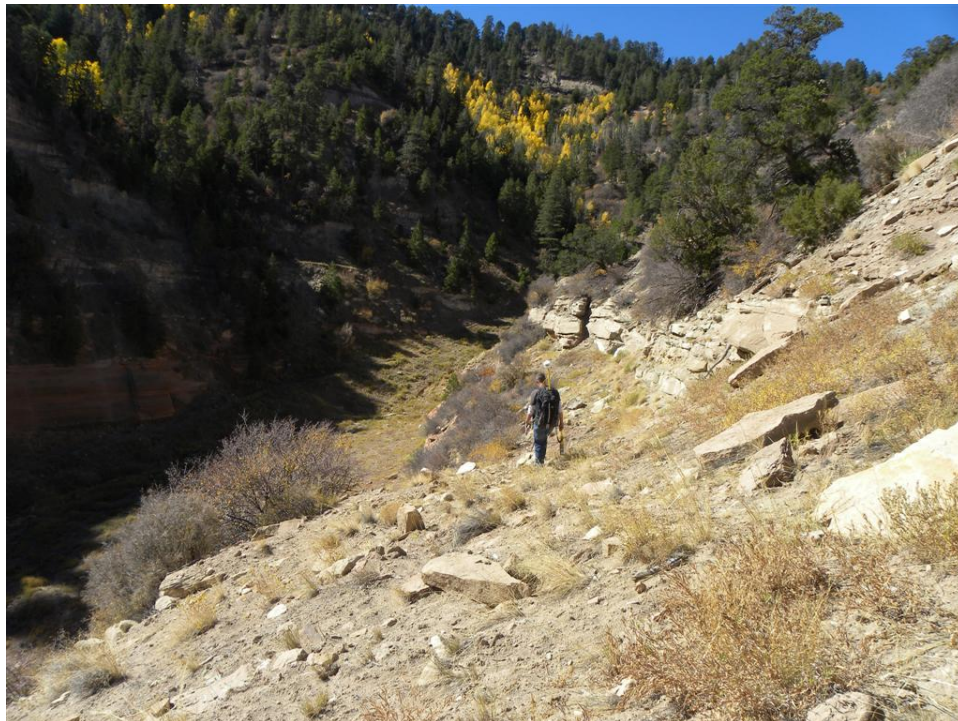
Photo 2. Cliff area and waste rock

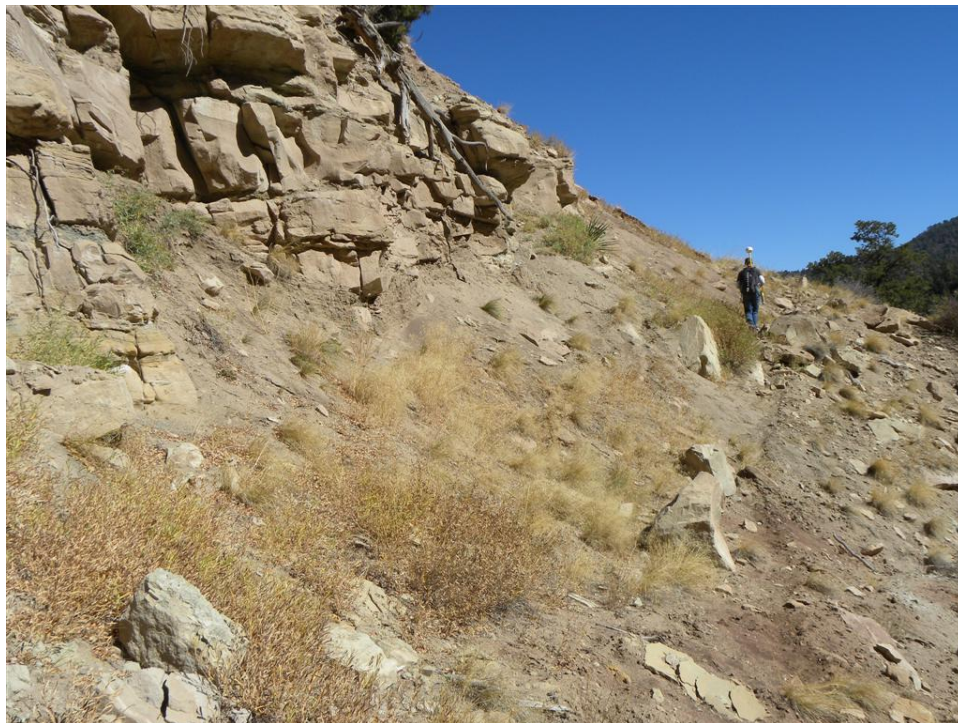
Photo 3. Waste rock

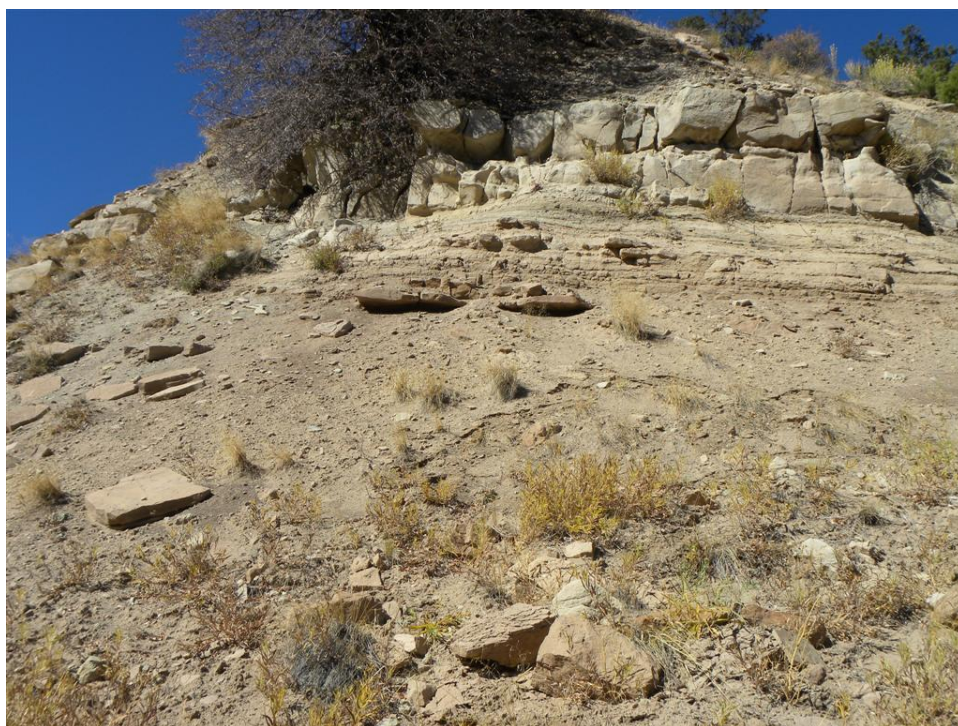
Photo 4. Waste rock
